Tangible Heritage of Kisvárda Castle

MA Thesis in Late Antique, Medieval and Early Modern Studies

Central European University

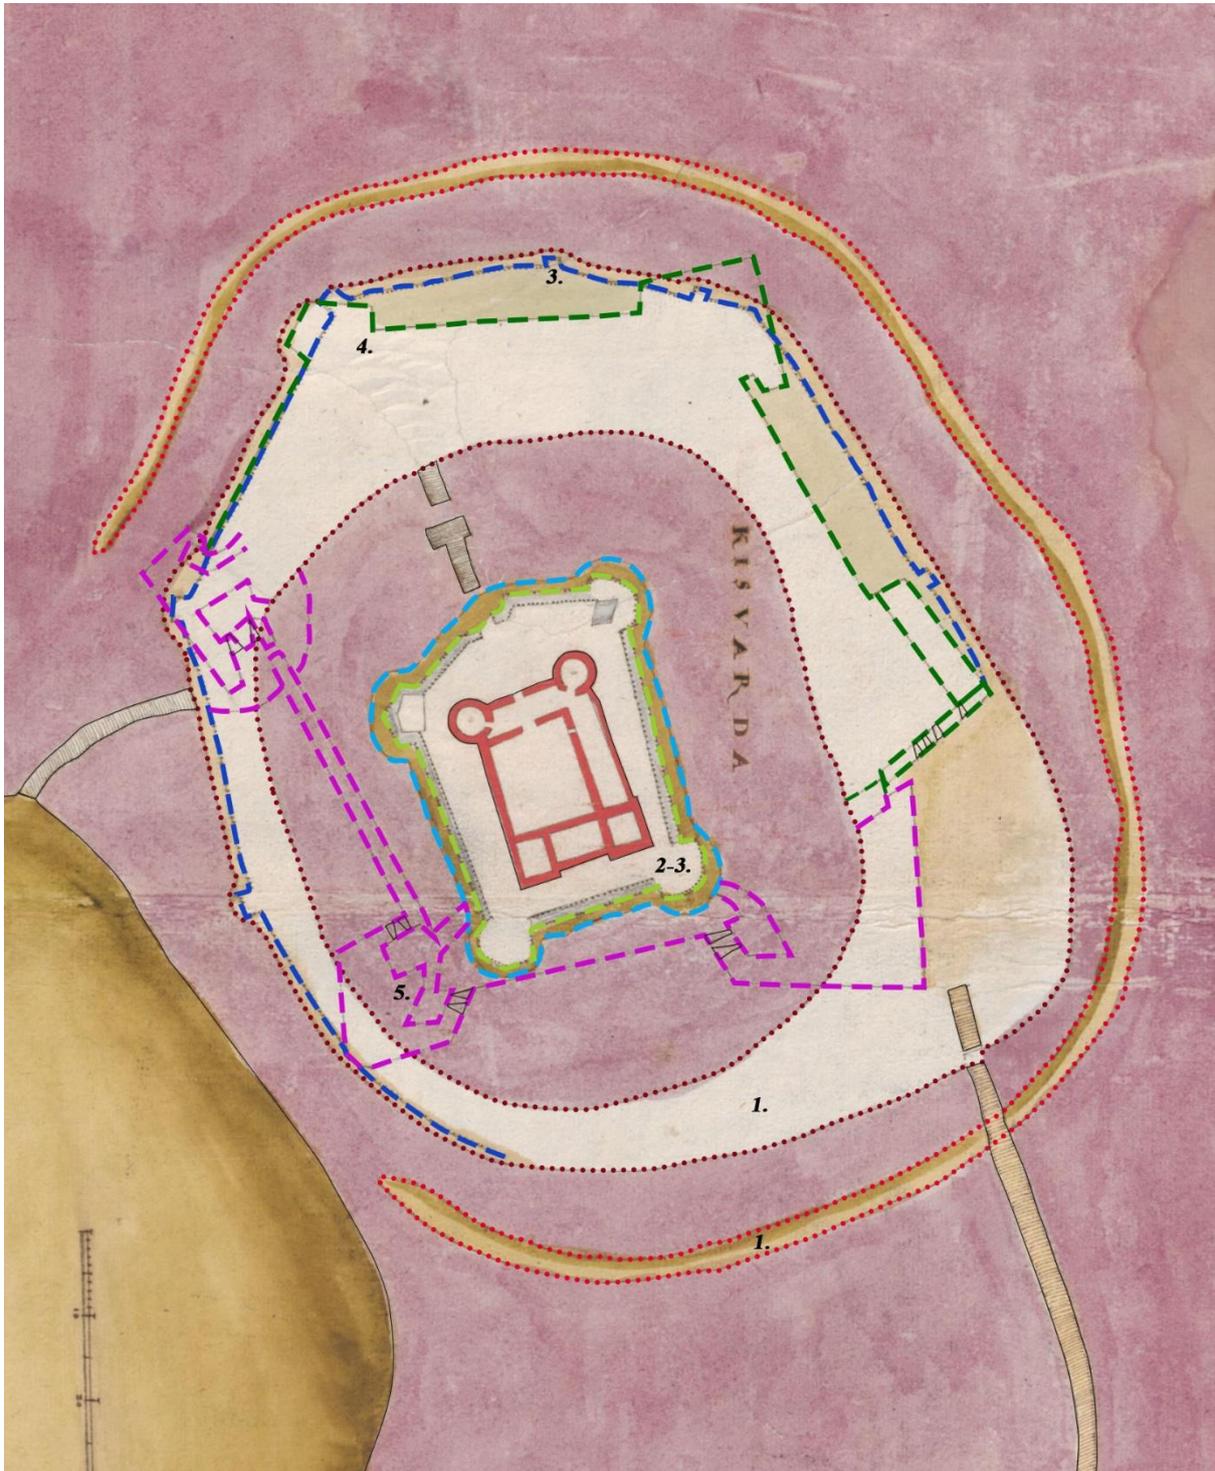
2. Figure: Periodization of the palisade structures. (Made by the author, based on the Vienna I map of the Angelini family.)

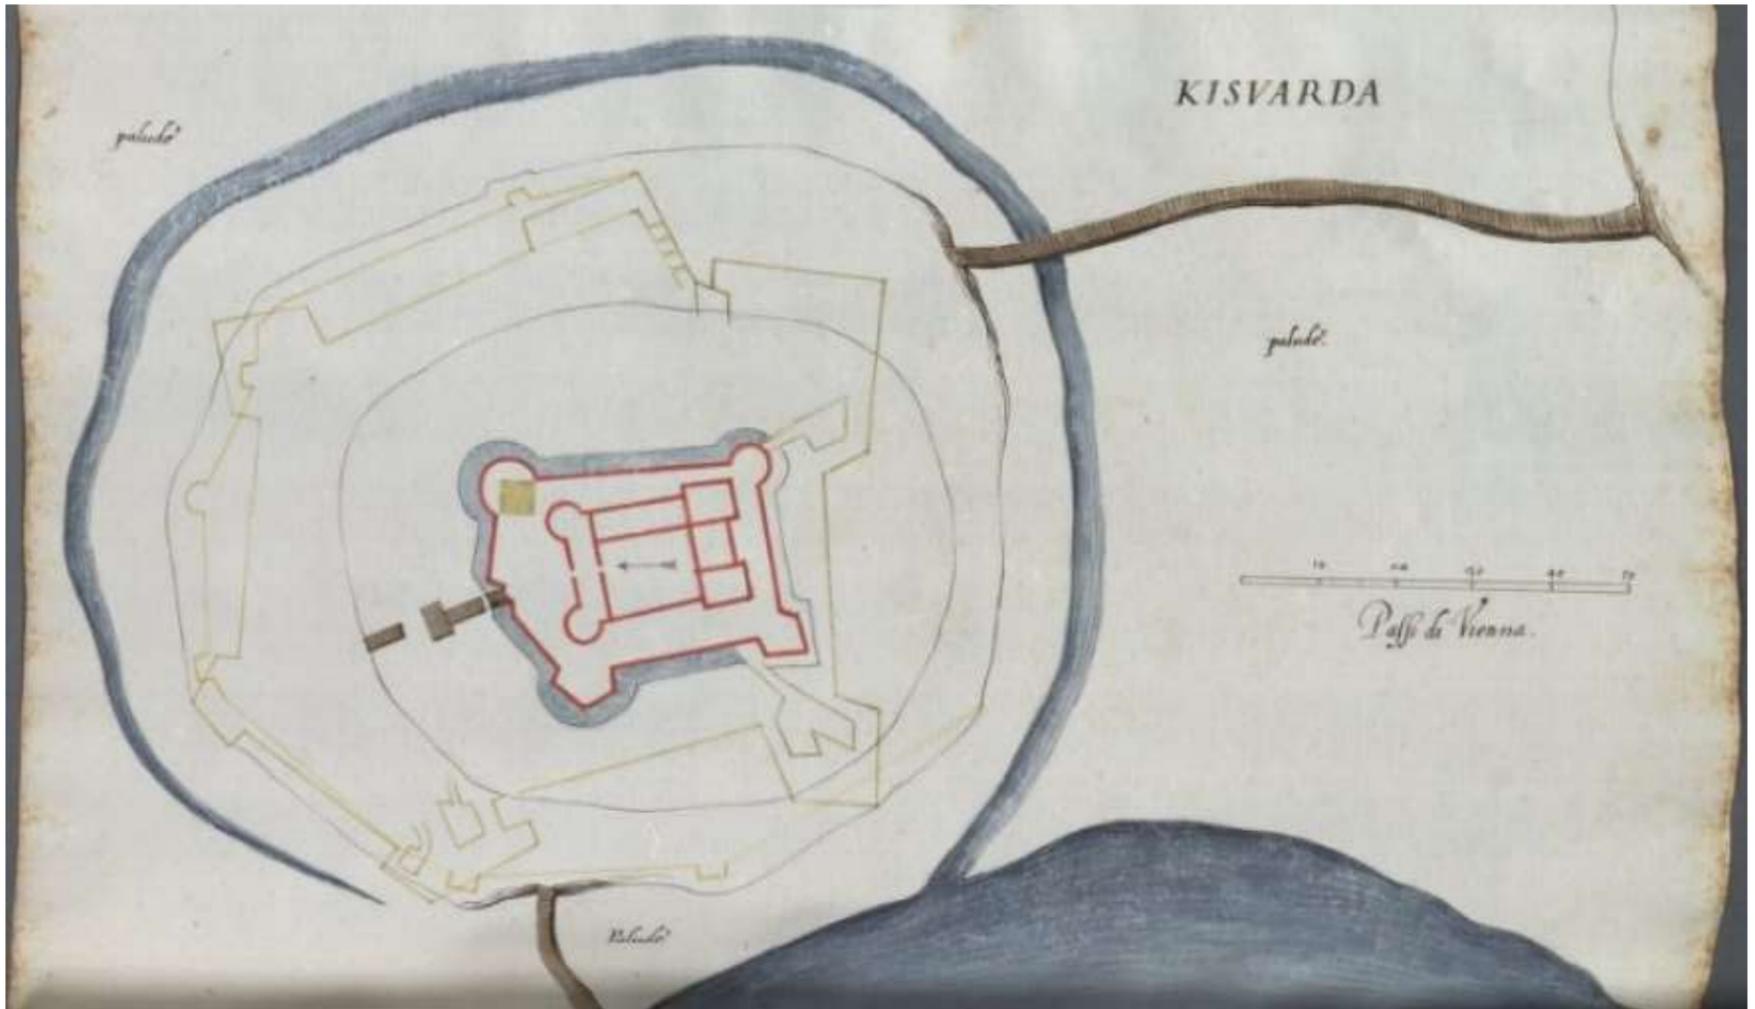
Figure 9. Kisvárd Castle in the Bayerische Staatsbibliothek, Munich, BSB Cod.icon. 141. (1570/1580-1610). (Source: https://codicon.digitale-sammlungen.de/Blatt_bsb00019801.00108.html?prozent=1)

The outermost line of earthwork seems to be connected to the inner, oval-shaped fortification lines. No built structure can be observed on it, only in the Munich depiction is it marked as a moat. (*Figure 9*)

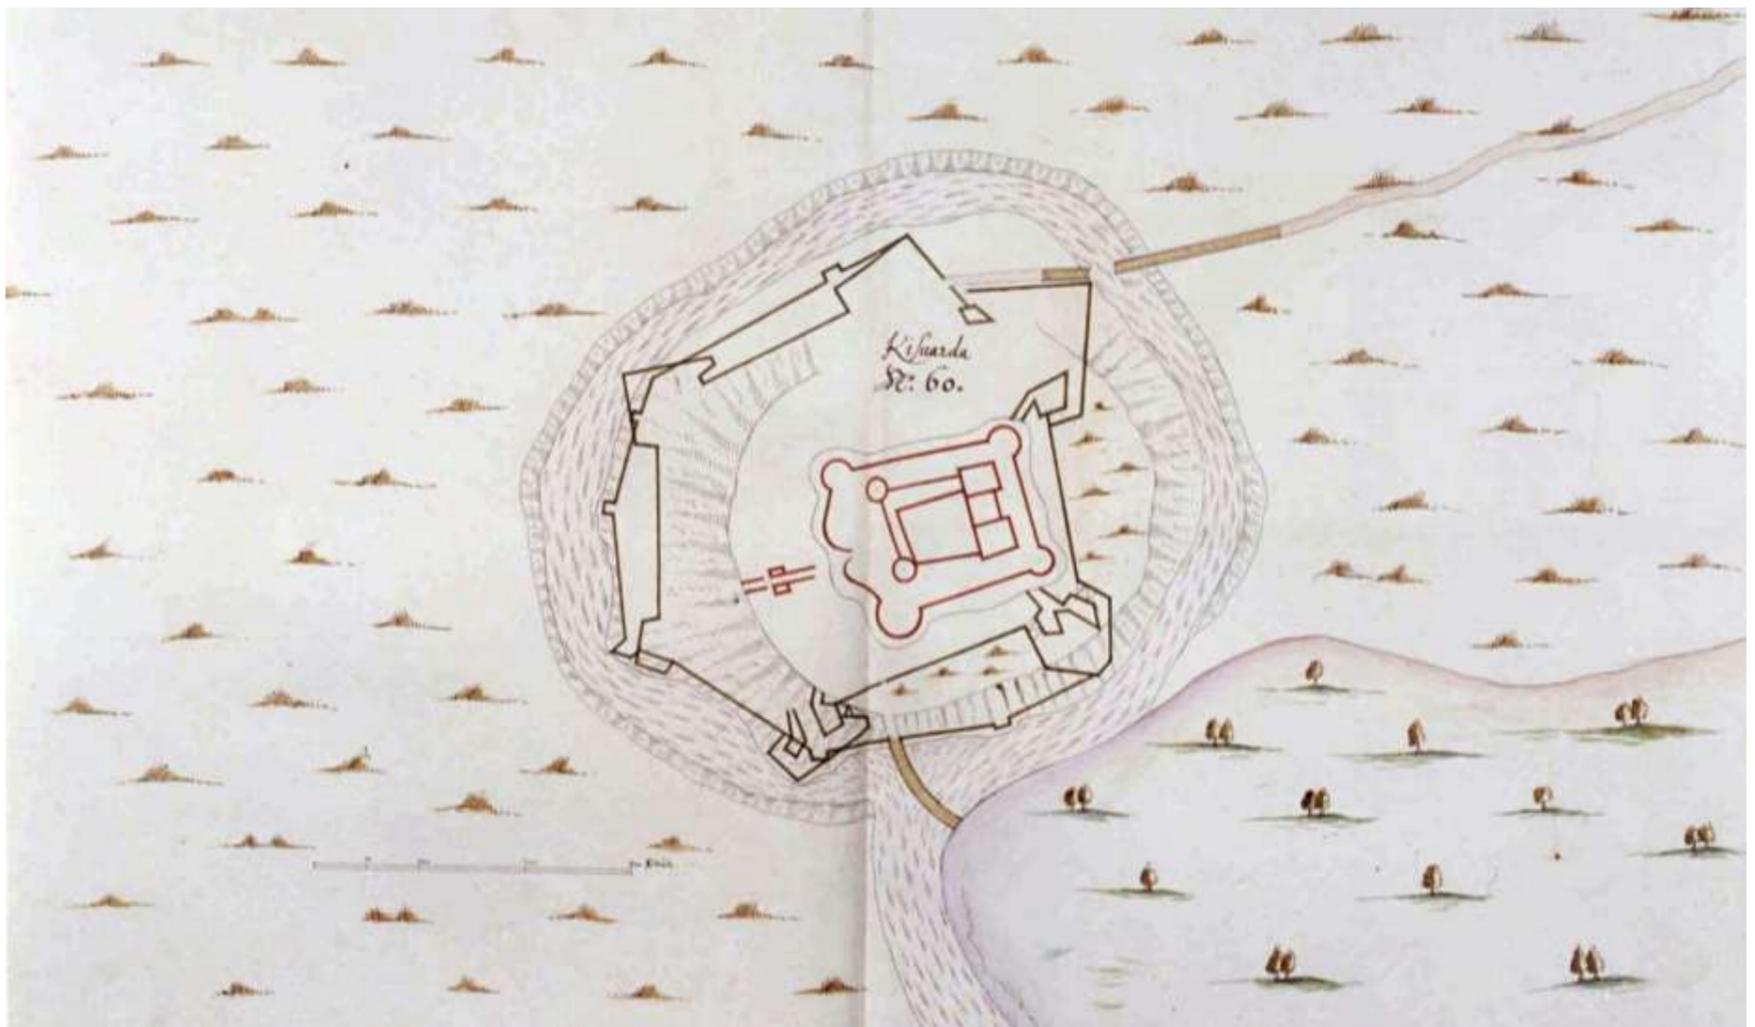
Figure 10. Kisvárd Castle in the Sockholm Album. (Stockholm, Kungliga Krigsarkivet, Handritade kartverk Nr. 23/59. 1650-1699?; György Domokos, "Törökkori Várak Stockholmában. Beszámoló a Stockholmi Királyi Hadilevéltárban Végzett Kutatásról [Ottoman Era Castle Drawings in Stockholm. Report on the Research Made in the Royal Military Archives]," *Hadtörténelmi Közlemények* 112, no. 1 (1990): 112–16.) (Source: <https://sok.riksarkivet.se/nad?postid=Arkis%20d8609198-29af-4479-b095-db07bc4d65a6>)

The castle moat before the building of the outer palisade could have been a partly natural partly artificial, wide, muddy area. It was slowly filling up with rubbish after the outer palisade has been built, during the use of the outer castle. Unfortunately, all the archaeological observations took place on the southern side, where the outer palisade had been built close to the inner structure, and the moat was narrow and filled up with rubbish soon. Thus, it cannot be stated for certain if there was a period of a narrow, artificial moat around the whole inner palisade like depicted on the Dresden album. Although with the analysis of the Ledentu albums by looking at the veduta and ground plan of Verebély (Figures 10a-b) a better picture can be

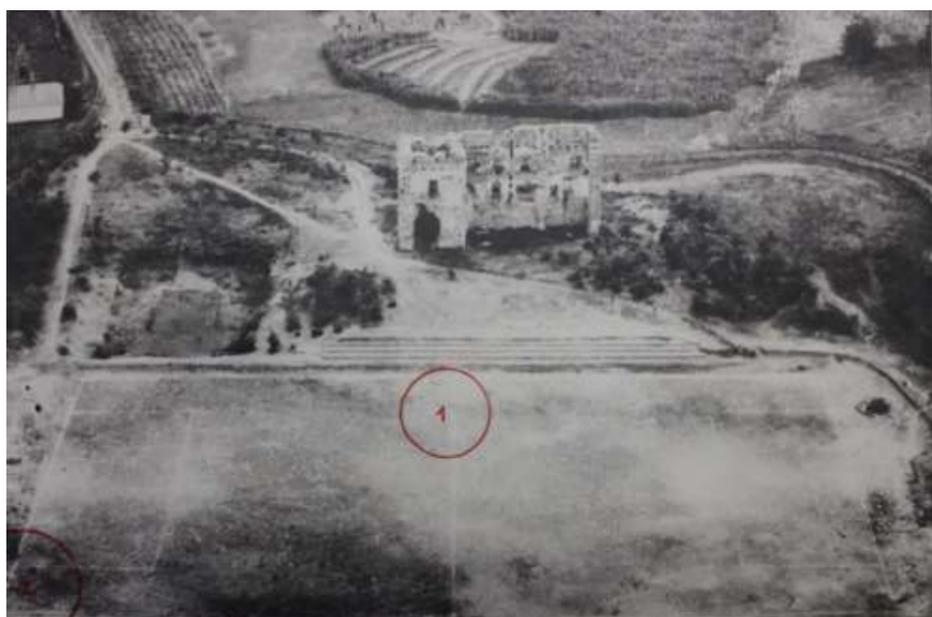
Figure 28. Aerial photograph of the castle from 1954. No 1. is the territory of the excavated and then destroyed walls, no. 2 is where Éri opened his trenches on the northeast bastion. On the right side of the photo the well, excavated in 1955, can be seen, while on the left the tennis court. The castle's surrounding is an agricultural area. (MNM 375.K.4; 1. picture)

In 1955 István Éri with György Szabó and Alán Kralovánszky continued the excavation of the well found in the football field, but all the material found inside was from the 1930s. (*Figure 28*) Alajos Sódor and István Éri surveyed the structure, but its documentation is lost.⁶⁸ The next year's documents contain only billings, and payment records, no excavation work took place.⁶⁹

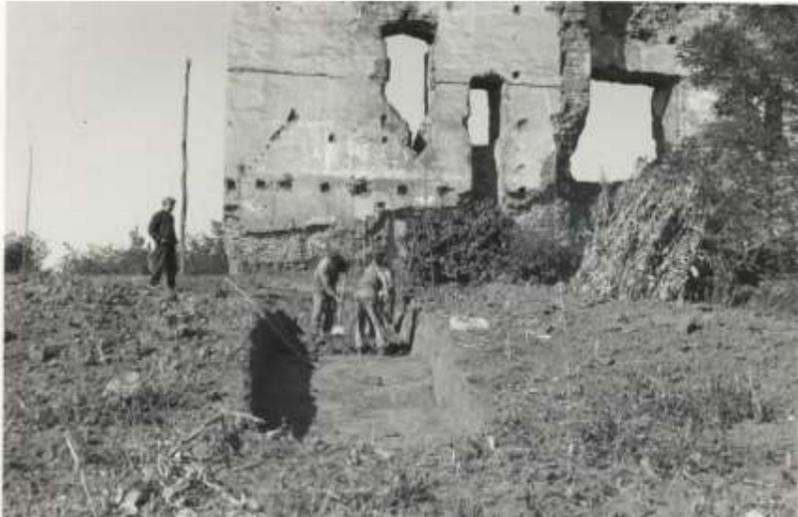
Figure 31. Opening the Trench 1957/I, on the southwest side of the castle. (Source: <https://www.vardaimuzeum.hu/hu/szolgaltatasok/galeria/regeszeti-napja-2020-0> Last access: 10.05.2022.)

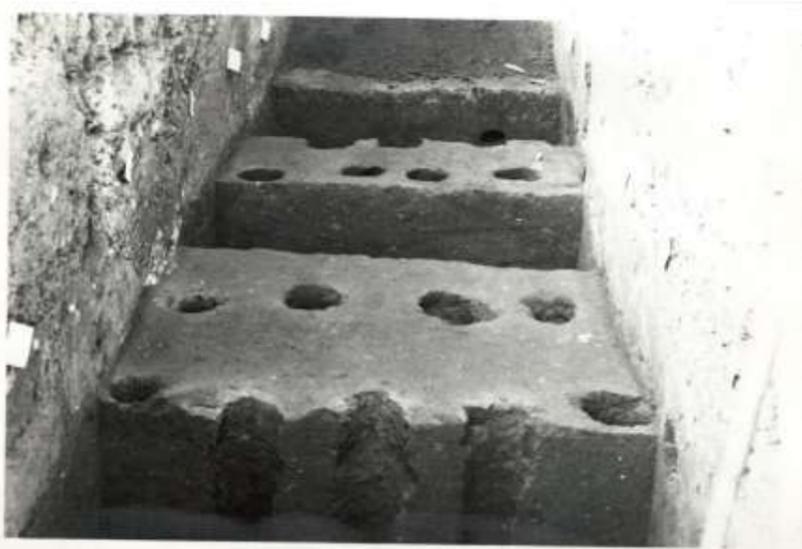
Figure 32. Trench 1957/I, the inner palisade after cutting half the postholes. (Source: <https://www.vardaimuzeum.hu/hu/szolgaltatasok/galeria/regeszeti-napja-2020-0> Last access: 10.05.2022.)

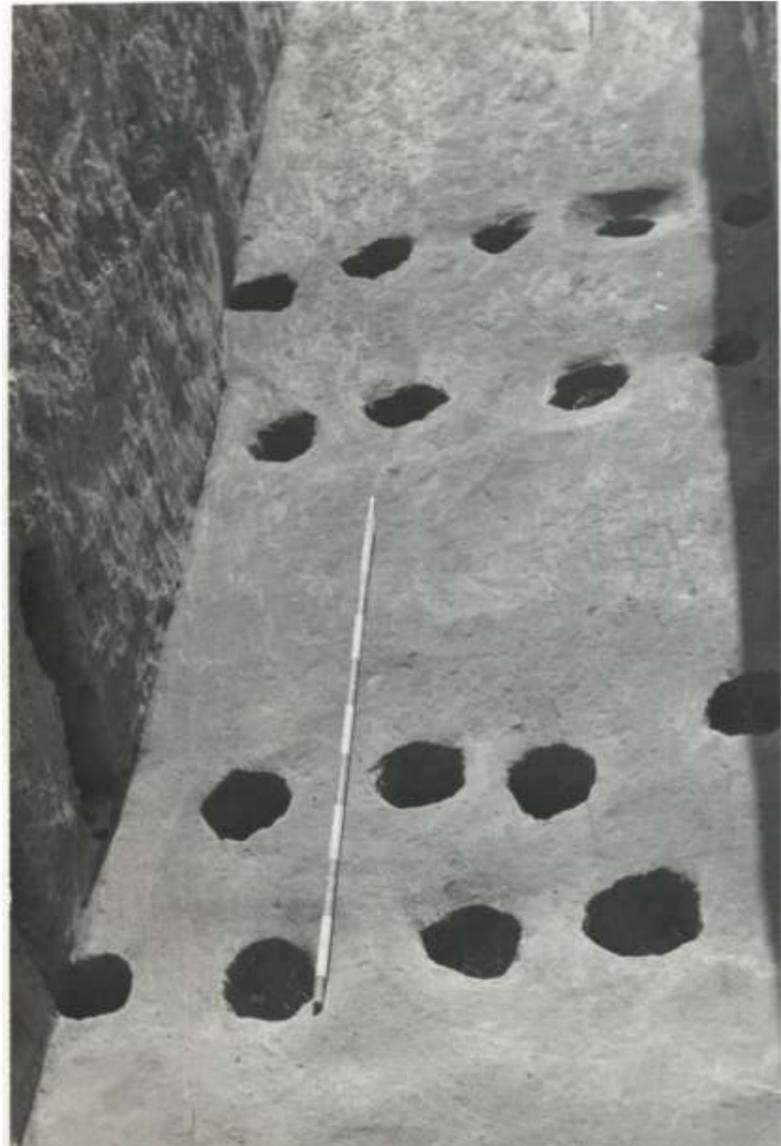
Figure 33. Trench 1957/I, the inner palisade. (Source: <https://www.vardaimuzeum.hu/hu/szolgaltatasok/galeria/regeszeti-napja-2020-0> Last access: 10.05.2022.)

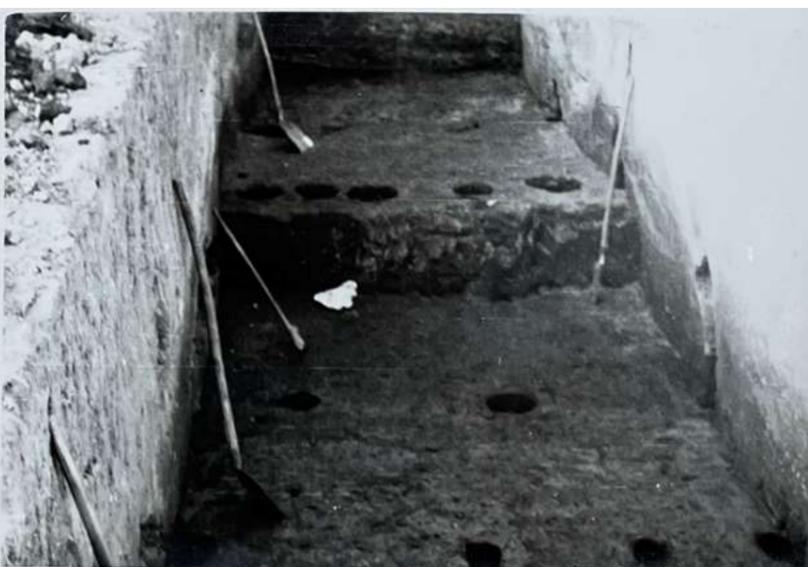
Figure 34. Trench 1957/I, the outer palisade structure. At the bottom of the picture are the remains of the posts, angled in 45 grade. (MÉM MDK Architecture Plan Collection, 25073, Table 31, Picture 52.)

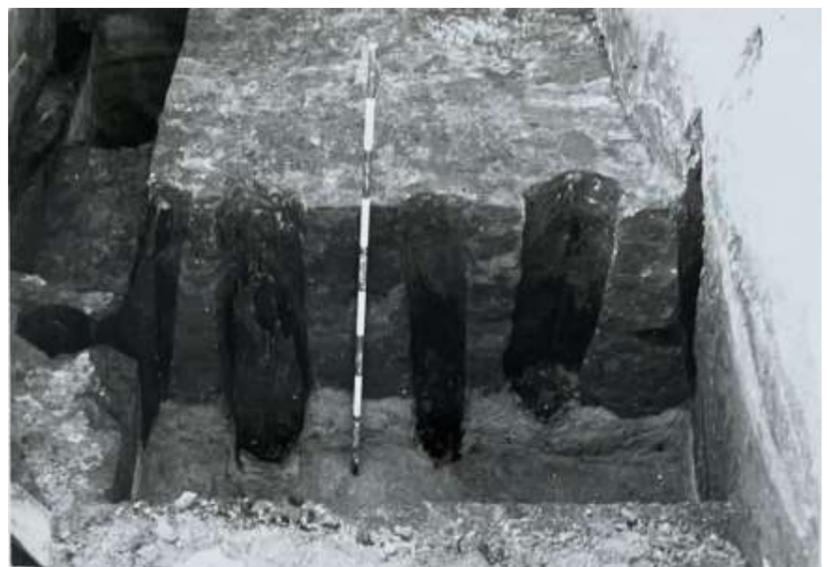
Figure 35. Trench 1957/I, the outer palisade's structure. The timber row is in the middle of the structure. (MÉM MDK Architecture Plan Collection, 25073, Table 31, Picture 53.)

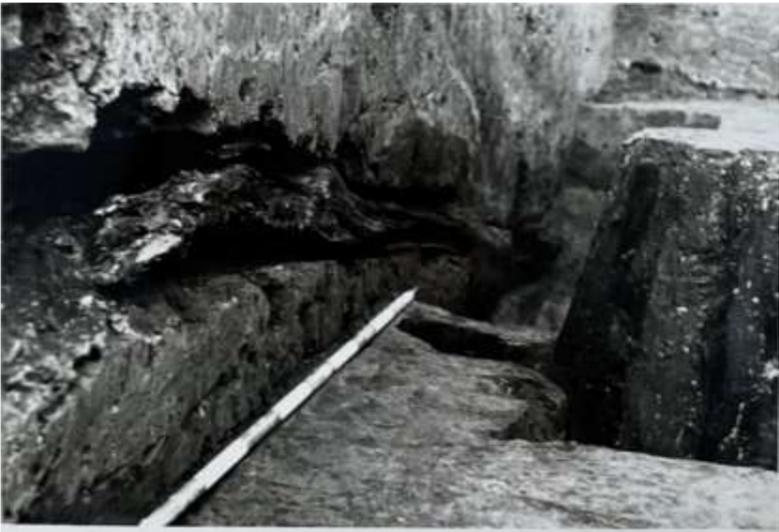
Figure 36. Trench 1957/I, the outer palisade's structure. The two meters long horizontal beam between the middle and outer posts. (MÉM MDK Architecture Plan Collection, 25073, Table 31, Picture 56.)

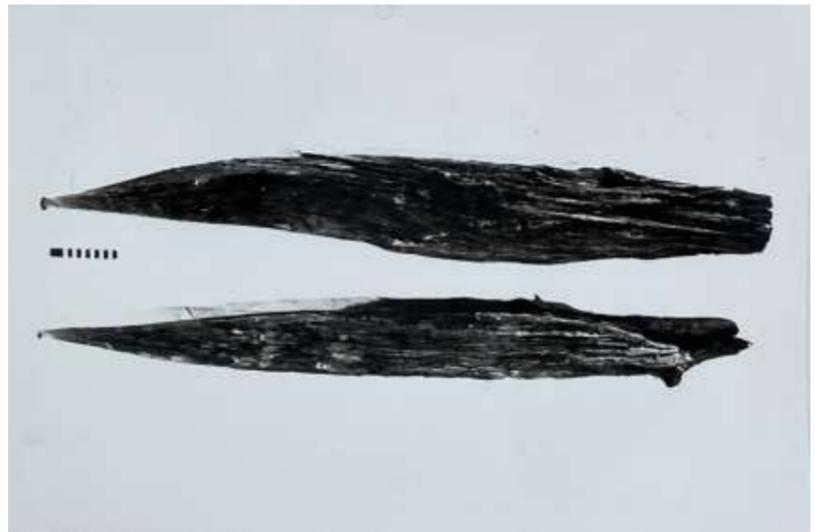
Figure 37. Trench 1957/I, timbers from the outer palisade's structure. (MÉM MDK Architecture Plan Collection, 25073, Table 31, Picture 57.)

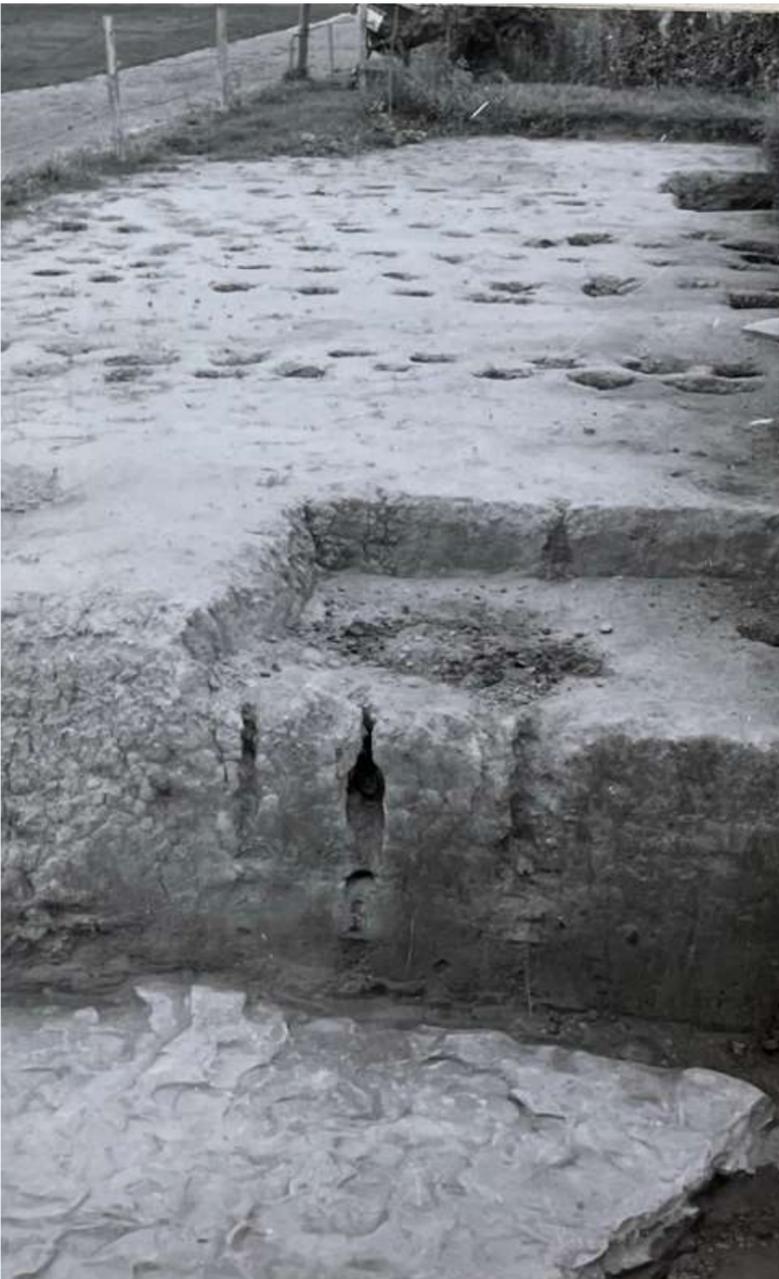
Figure 39. Trench 1960/east-west. The photo was taken of the eastern end of the trench. (MÉM MDK Architecture Plan Collection, 25074, Table 35, Picture "b")

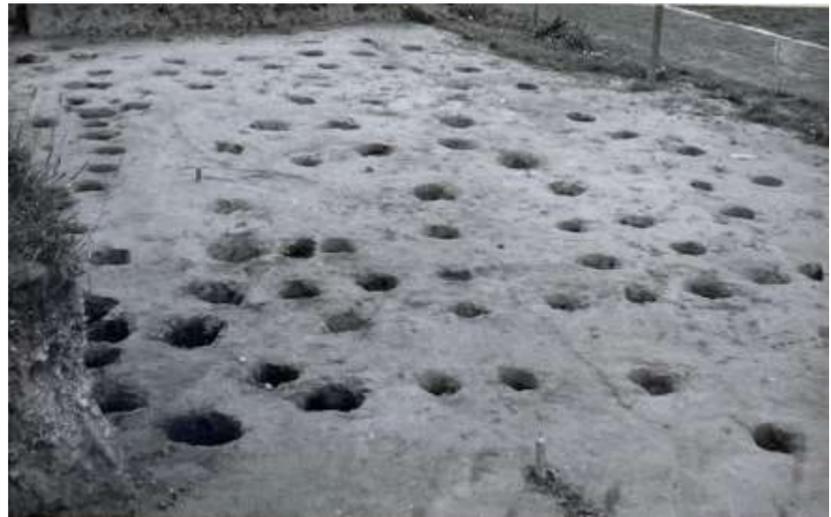
Figure 40. Trench 1960/east-west. The photo was taken of the western end of the trench. (MÉM MDK Architecture Plan Collection, 25074, Table 36, Picture "b")

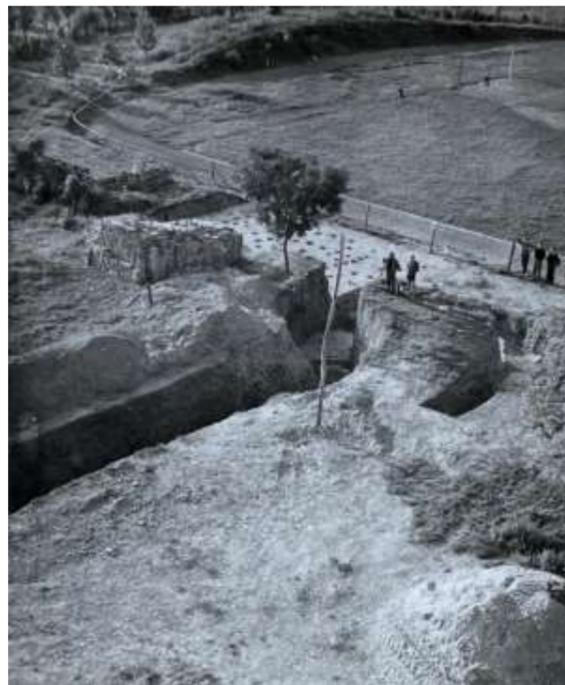
Figure 41. Trench 1960/east-west. The photo was taken of the western end of the trench. Behind the trench the football field and the northwest bastion can be seen. (MÉM MDK Architecture Plan Collection, 25074, Table 28, Picture "a")

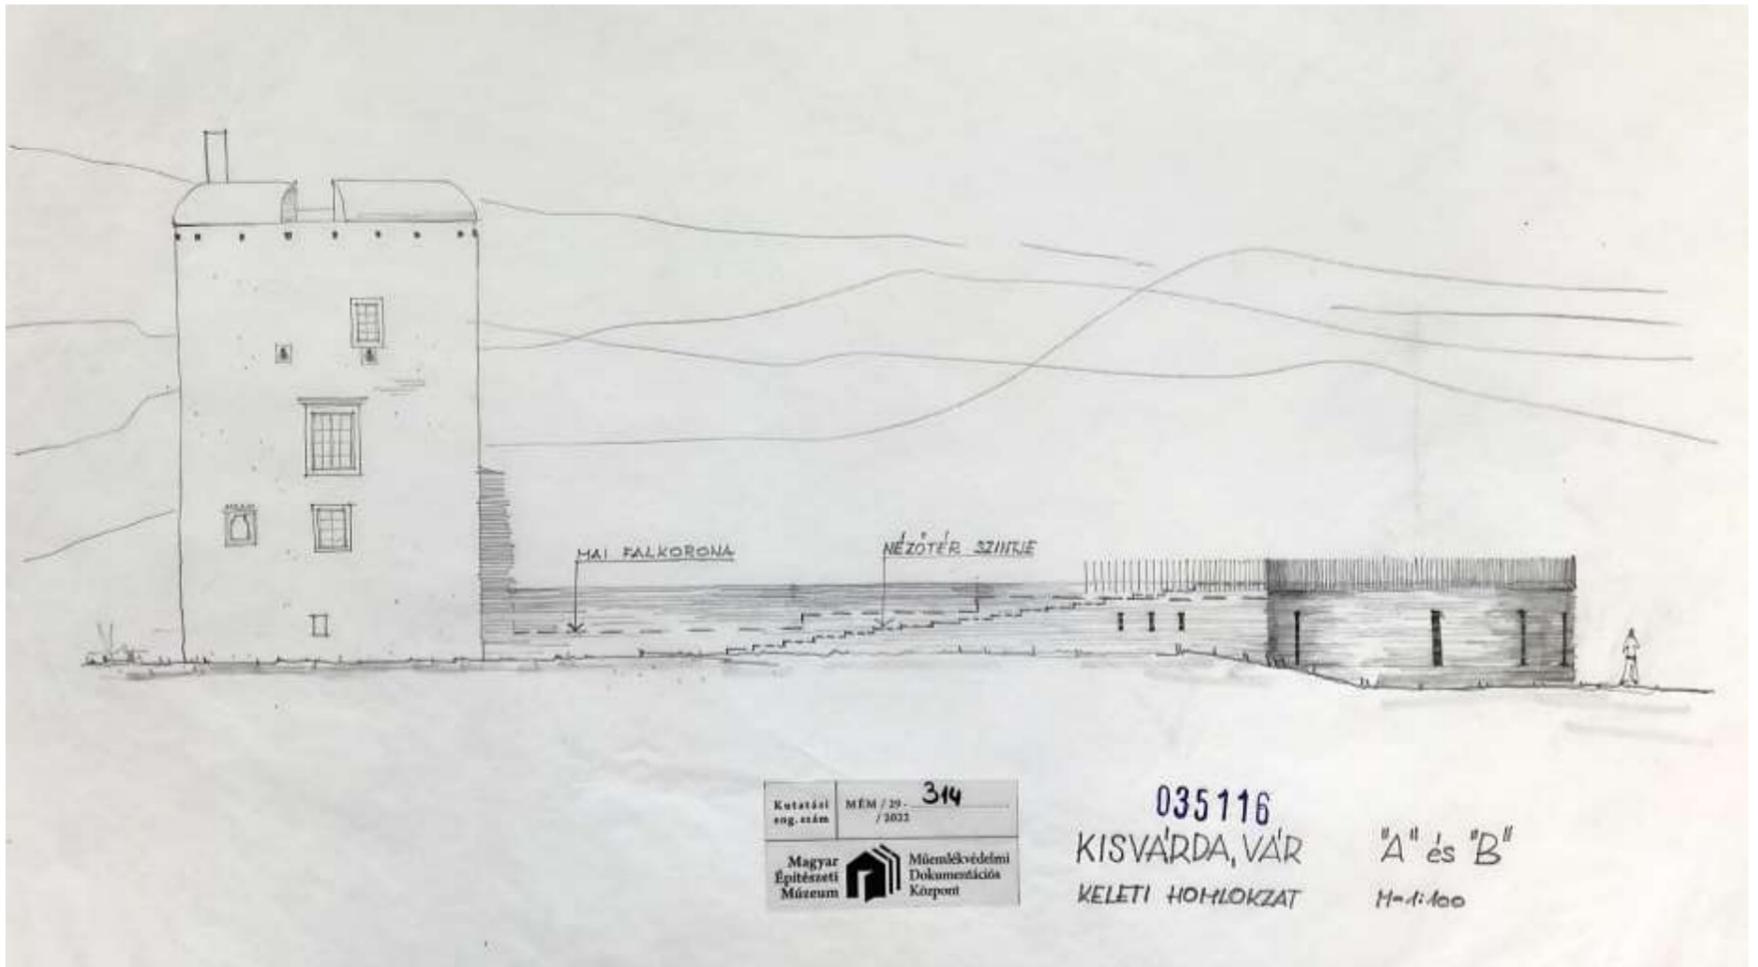
Figure 50. The cross-section of the plan variations by József Erdős, in 1970 (MÉM MDK Architecture Plan Collection, 035116)

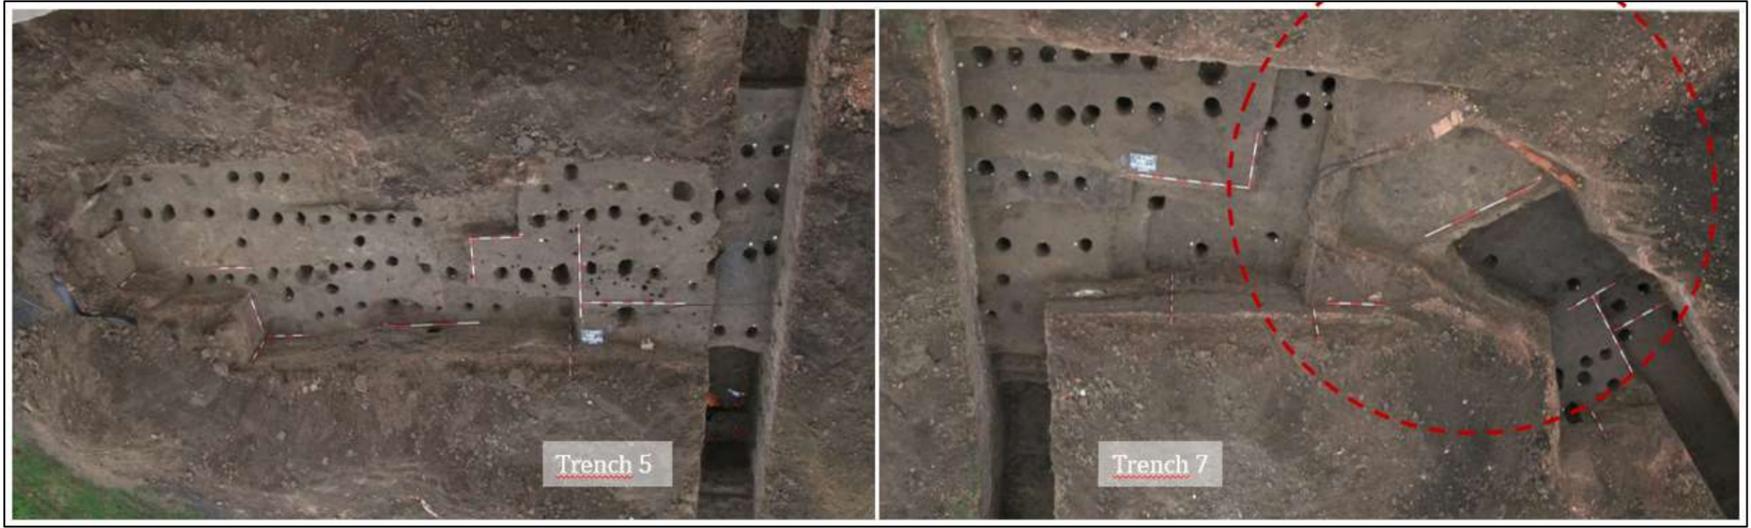
Figure 59. The structure of the inner palisade's second period in trenches 5 and 7.

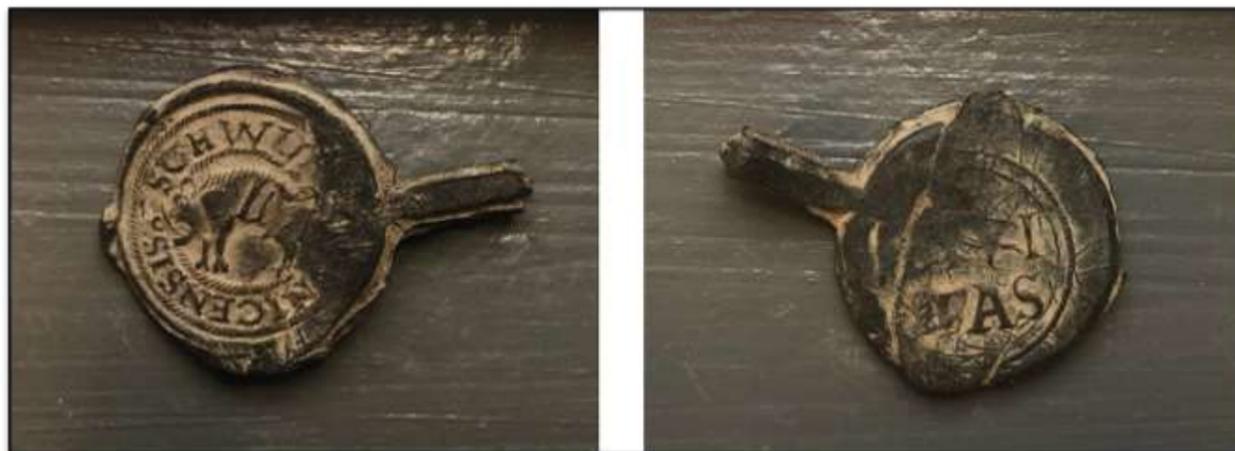
Figure 61. Lead seal from Schweidnitz (now Świdnica) in Polish Silesia.

lead seal, a trademark from the beginning of the sixteenth century (*Figure 61*). The front of the seal shows a wild boar in the center, with the inscription SCHWEIDNICENSIS. The reverse is fragmentary, but in all likelihood it is inscribed [CI]VI/TAS, indicating that it is a city-level authentication. The cloth stamped with this seal was of higher quality fabric, coming from Schweidnitz (now Świdnica) in Polish Silesia.¹⁷⁴

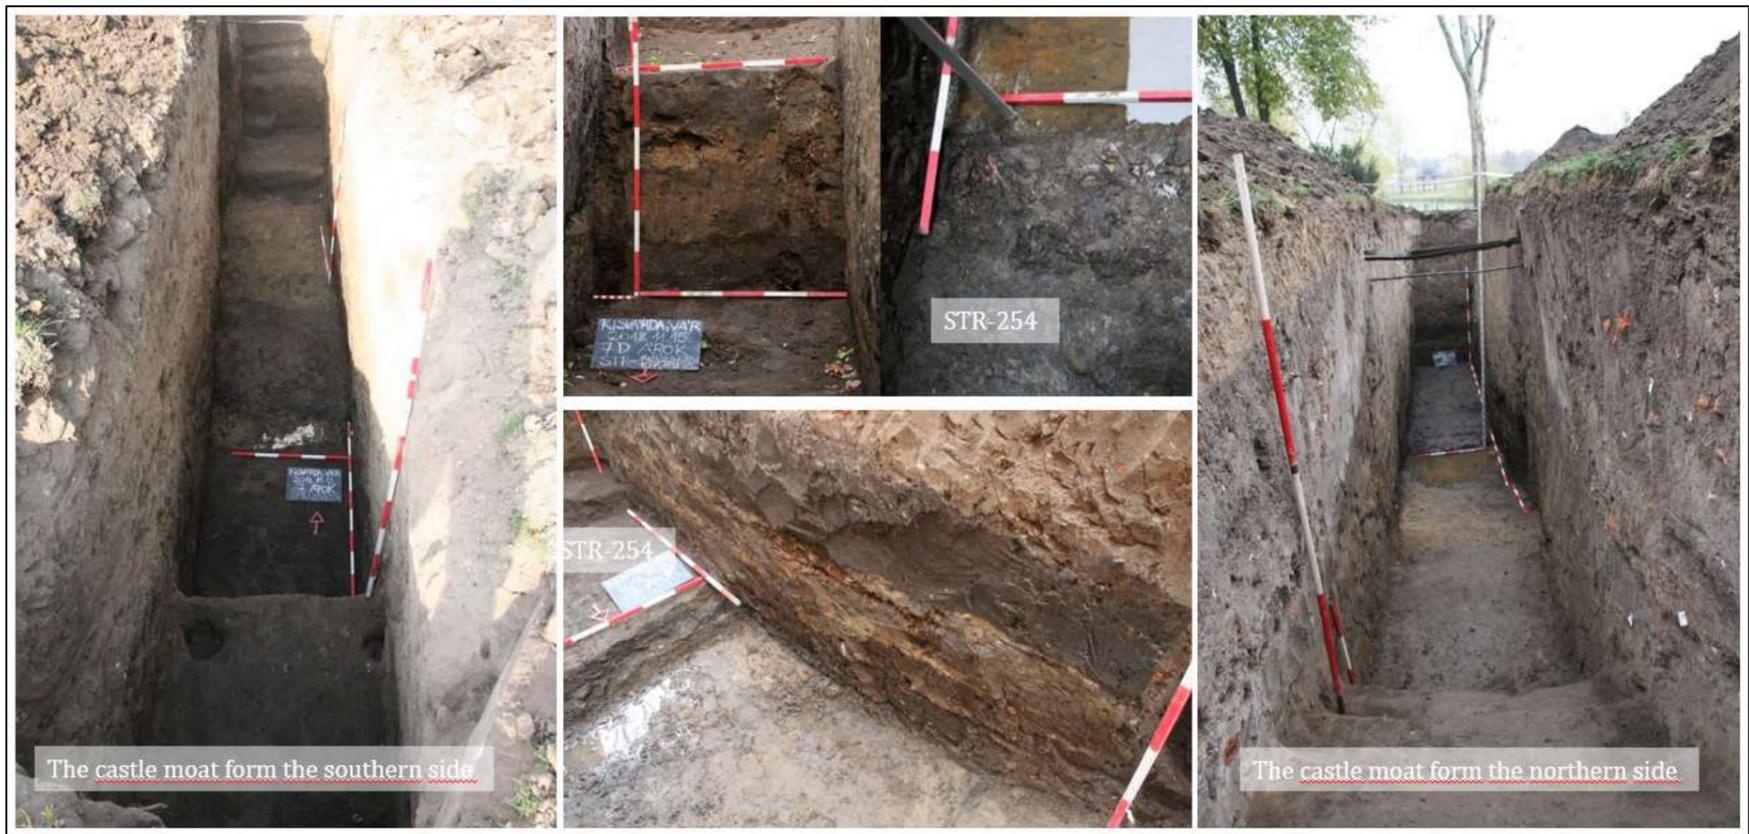
Figure 63. The castle moat in trench 7.

The castle moat and the rubbish layers formed in it were found in trench 7. (*Figure 62*) In my understanding, the preserved moat was about 5 meters wide at the bottom, between the two palisade structures. At the bottom of the moat, on the sloping subsoil a clay layer, full of small organic residues and wattle was preserved (STR-254, *Figure 63*). The northern side of this layer covered the inner palisade, moreover, south of the outer palisade structure was built on it. The layer could be dated by two coins of Ferdinand I, one of them from the year 1543. Thus, both palisades' relative dating can be linked to an absolute date.¹⁷³ Thus the coin for the inner palisade gave *a terminus ante quem*, and for the outer palisade *a terminus post quem* dating. This watertight clay layer could have been formed naturally during the time when just the inner palisade was standing, or it could have been deliberately laid on the muddy surface so that the outer palisade structure could be accessible and could be built. Unfortunately, the layer could not be followed to its whole extent, because the modern road of the park at the end of trench 7 could not be demolished.

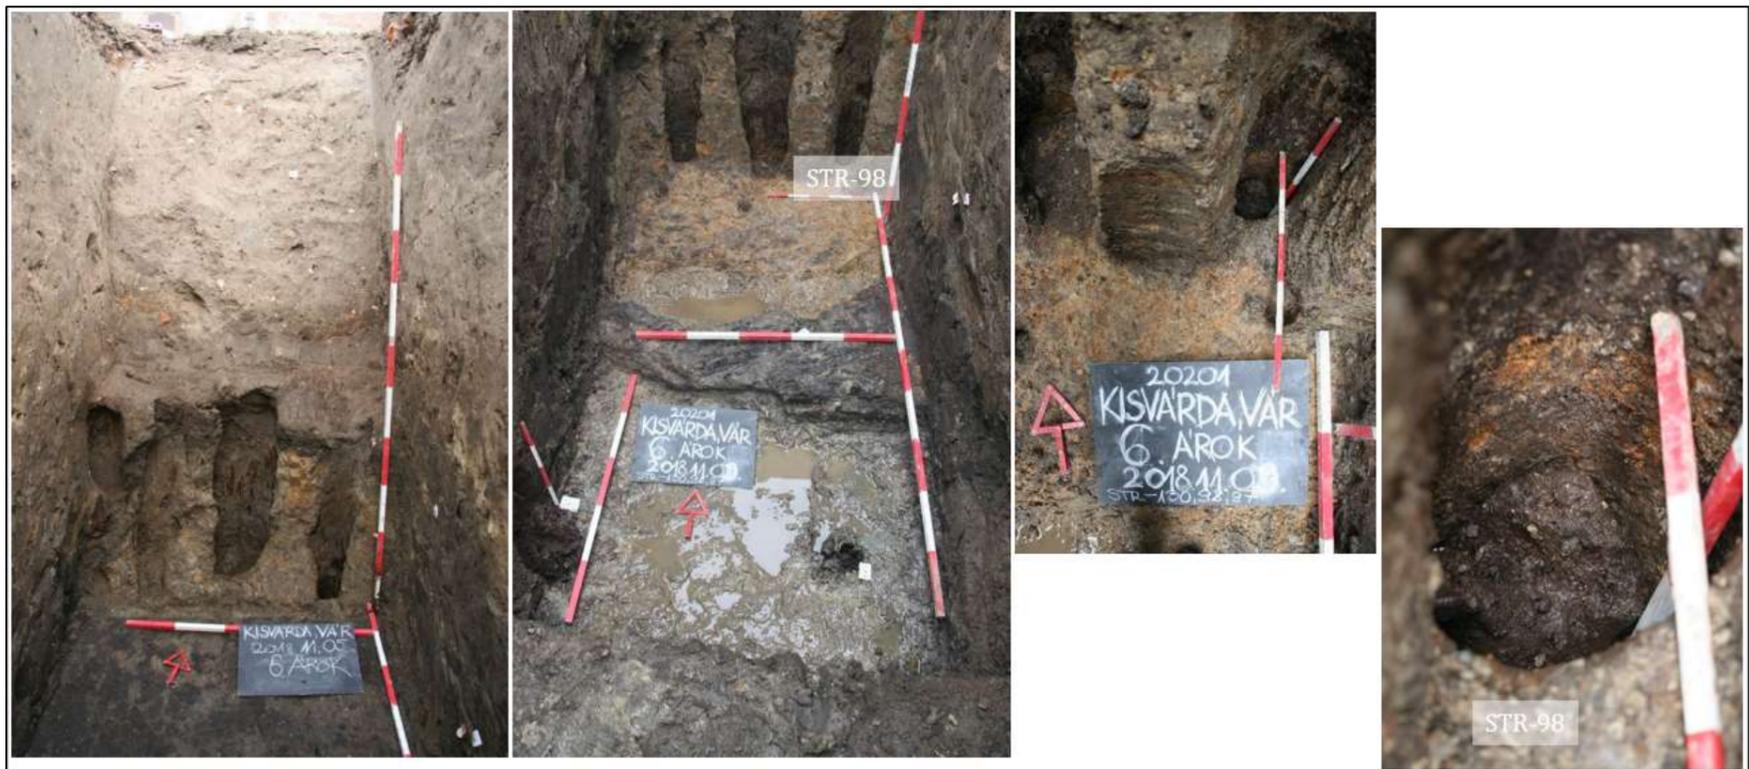
Figure 64. The outer palisade on the southern side, in trench 6.

The structure of the outer palisade was studied at trench 6. (*Figure 64*) Similarly to Éri's finds both in trench 1954/II and trench 1957/I the palisade was supported by three main rows of posts, and one additional on the outer side, built from smaller elements. The phenomena described by Éri were provable, even if the northernmost row was not accessible in 2018, because of the park road. On the slope firstly the firm basis was established from clay on the two sides of the outer, third row of posts. Then on this basis, was the whole construction built, between the tree post rows with the addition of some smaller vertical branches, yellowish and gray clay, wattle, and soil mixed with whitewash layers were piled up, for stabilization. Between the second and third rows, vertical rows of some horizontal elements were laid, and some horizontal postholes were revealed in the profiles. The supplementary fourth row was shielding the wattle and daub covering from the outside. The posts' ends were sharpened to square-cross-sectioned. Three of the posts we took out and sent to laboratory analysis. One of them, sample 2, (STR-98) had an absolute date of 1601. It was in the northeast corner of the trench, so presumably in the second row of the structure.

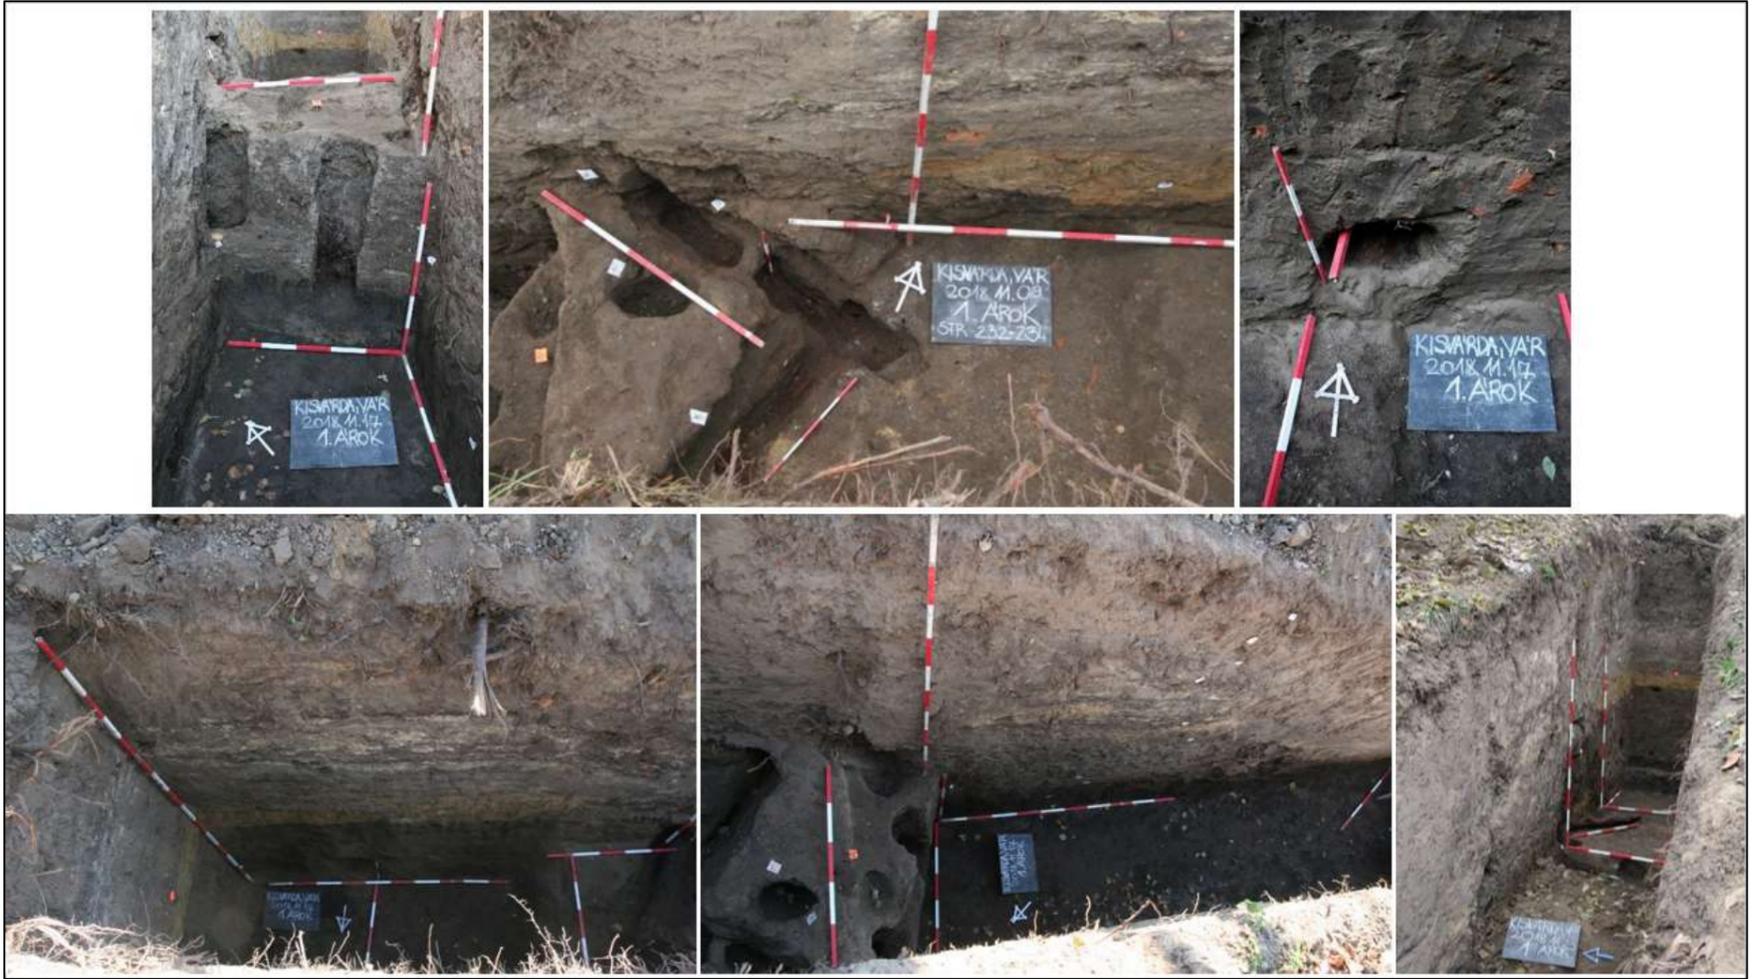
Figure 68. The northwest bastions structure in trench 1.

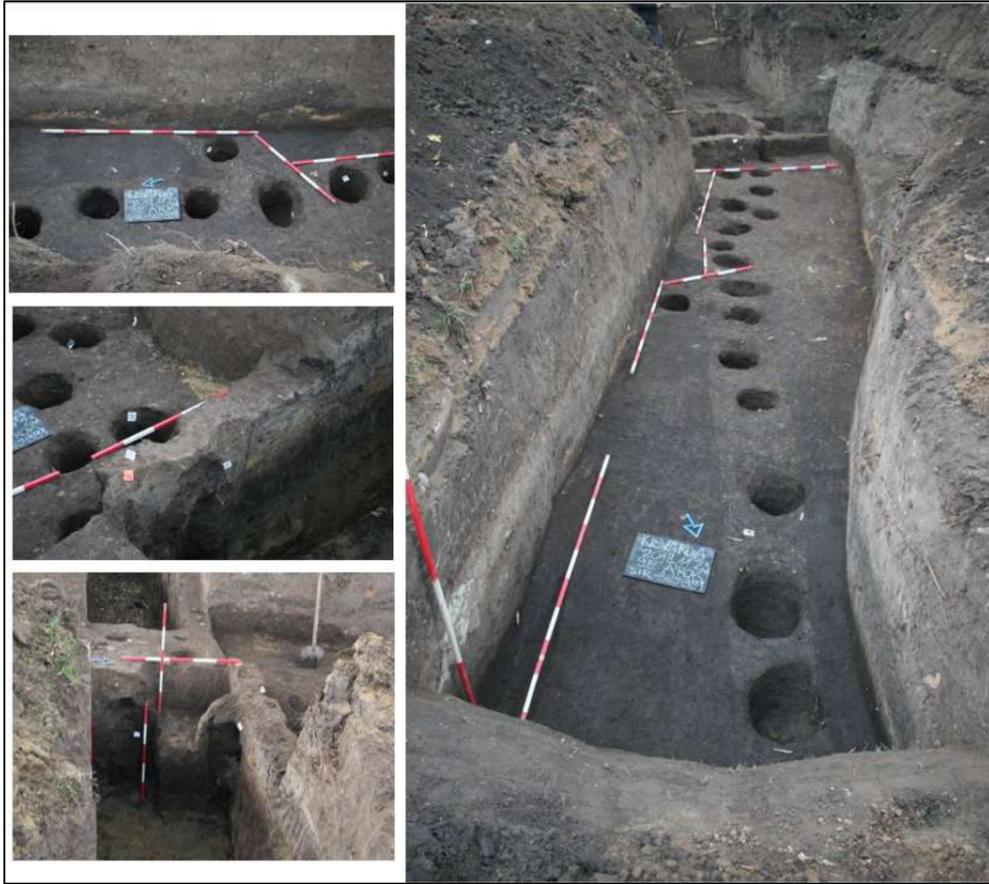
Figure 70. The southeast gate of the outer palisade.
