Tangible Heritage of Kisvárda Castle

MA Thesis in Late Antique, Medieval and Early Modern Studies

Central European University

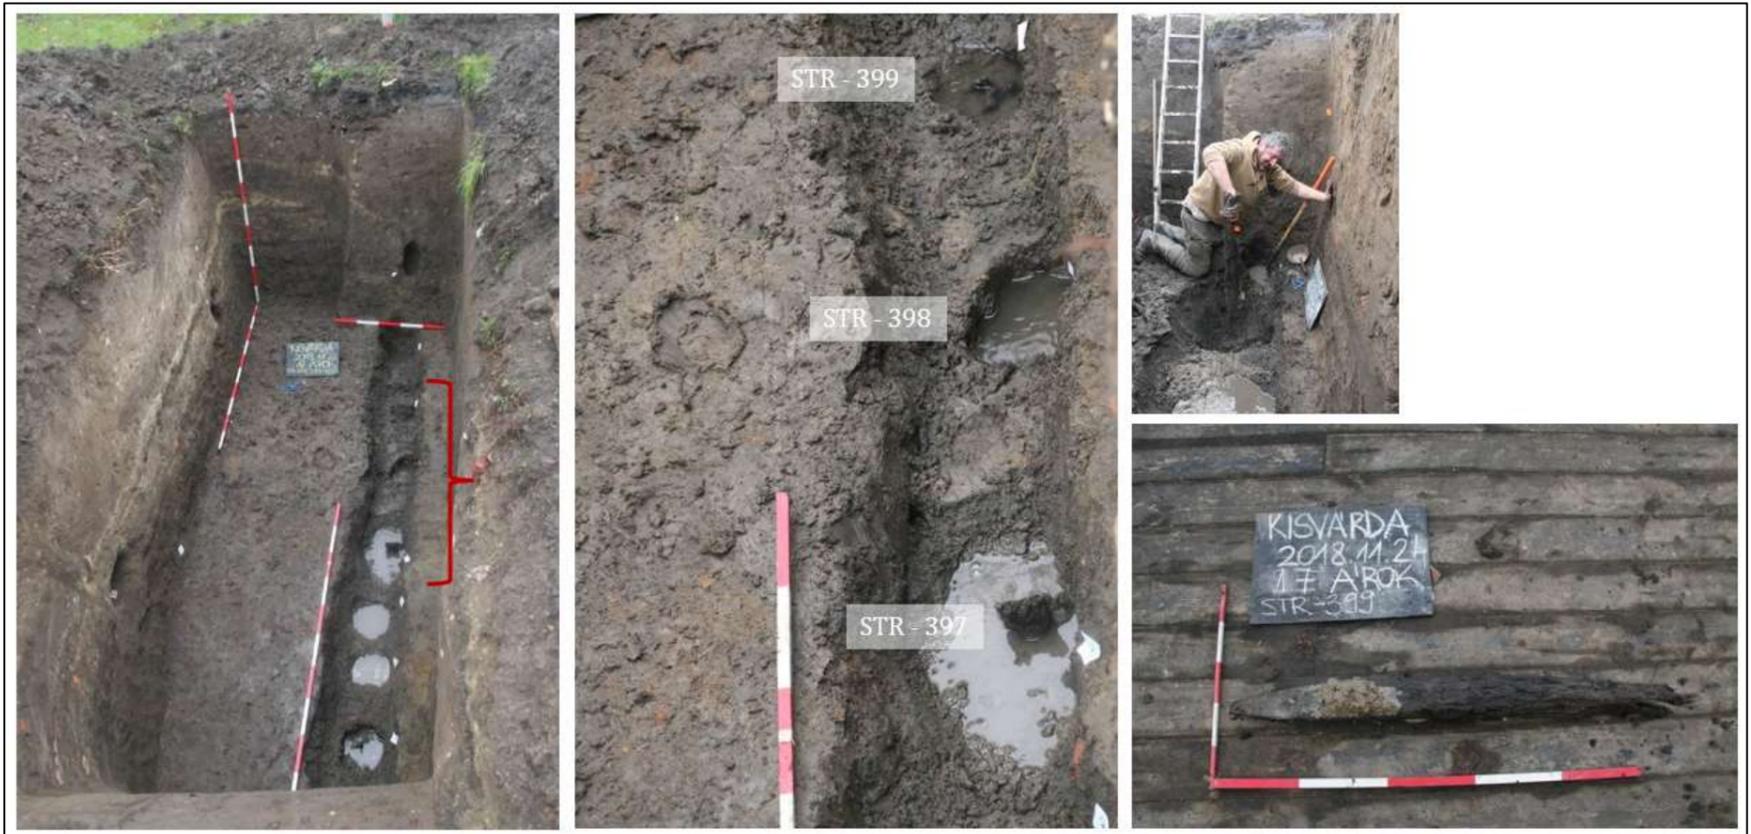
Figure 71. The northwest gate and the wooden remains.

the gate was found. Here three sharpened trunk samples were collected, all of them cut out in the same year, 1601 (*Figure 71*).

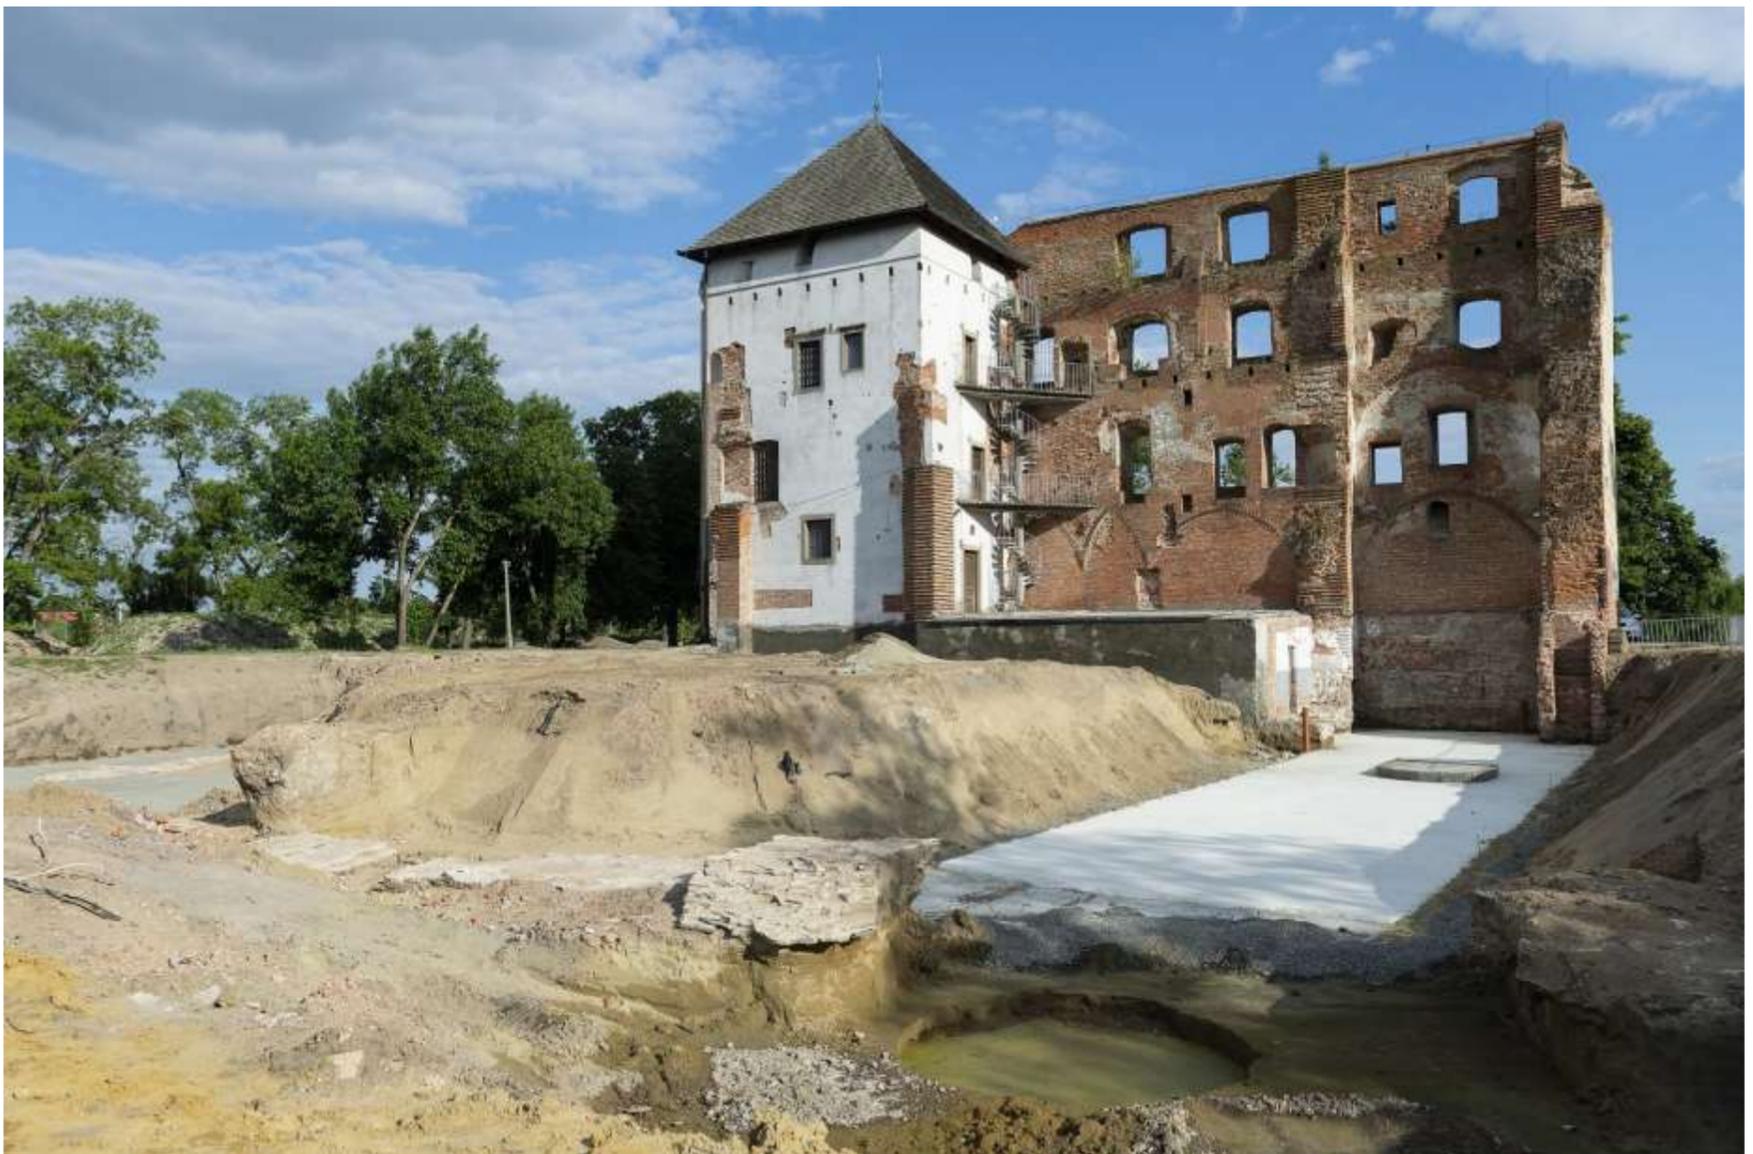
Figure 76. Augurating of the new structure, 2021 May. Medieval foundations under precarious conditions. (Source: <https://www.origo.hu/kultura/20210603-elkezdodott-a-kisvardai-var-fejlesztese.html>, Last access 10.05.2022.)

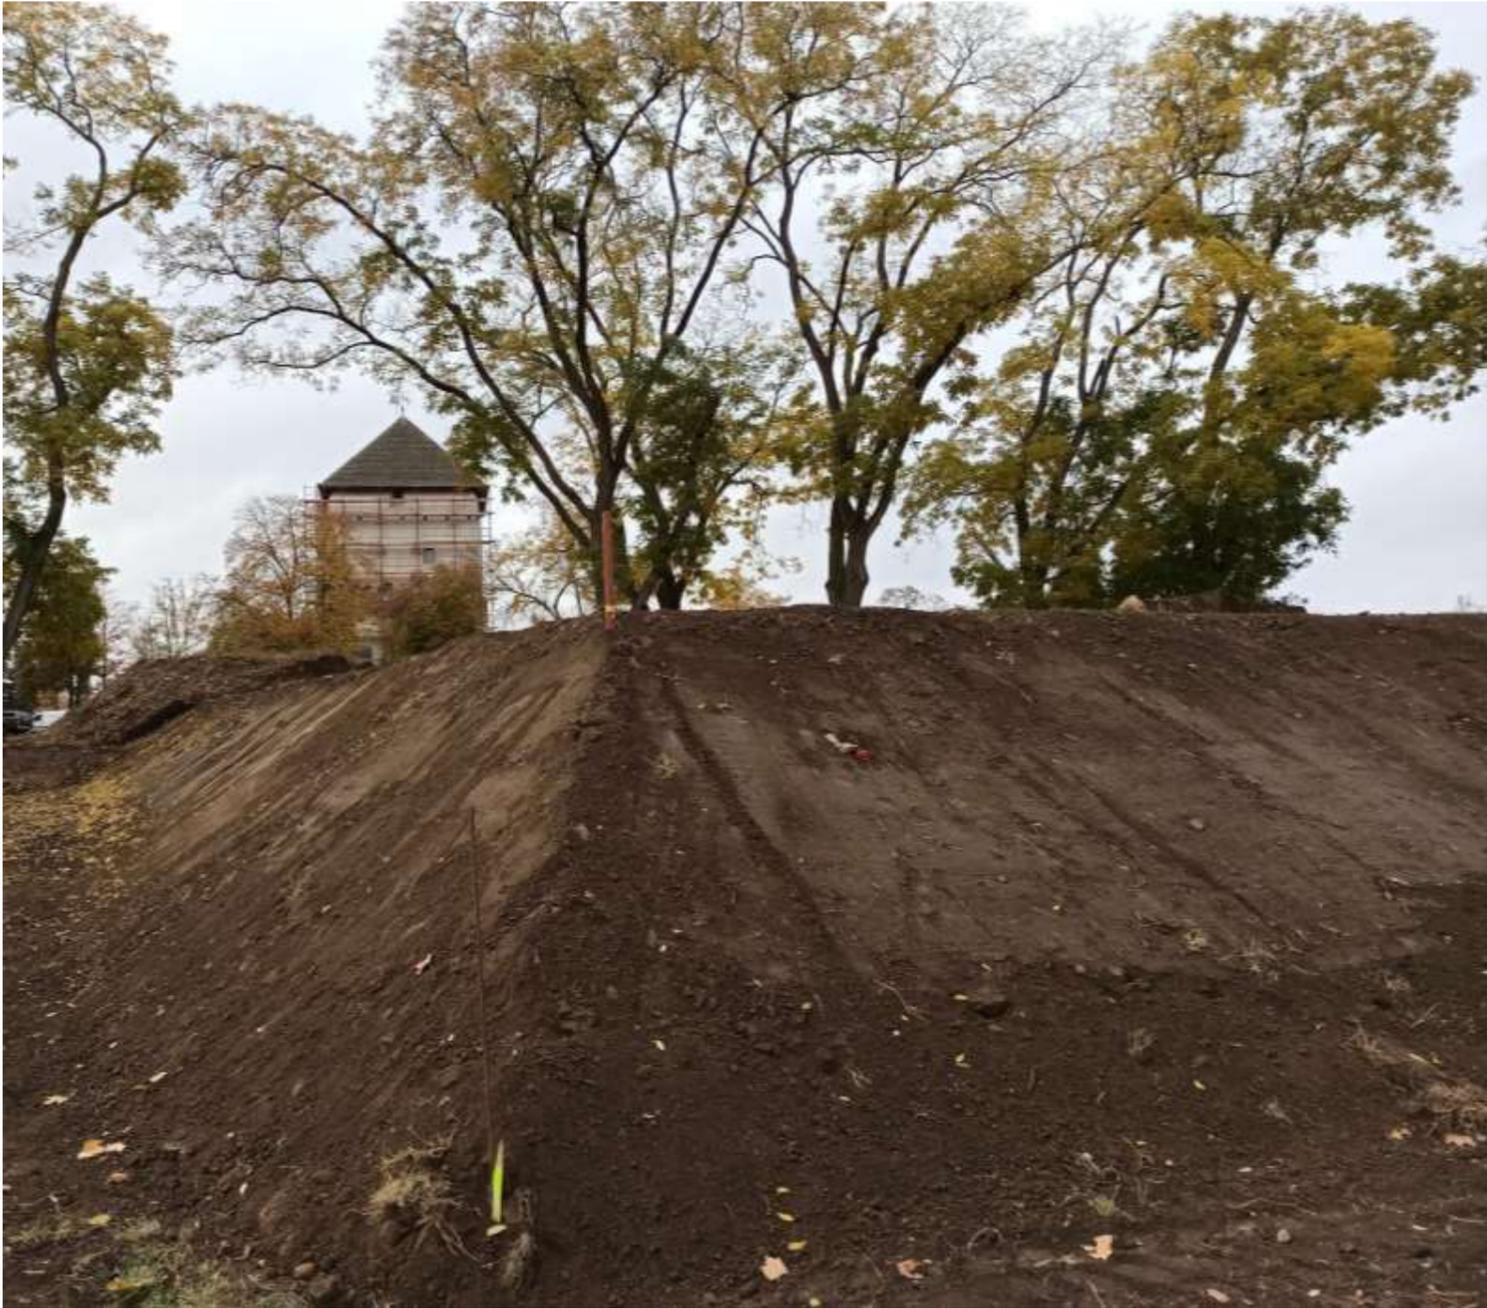
Figure 77. The reshaping of the palisade at the southwest bastion. Photo taken by Zsuzsanna Árvai.

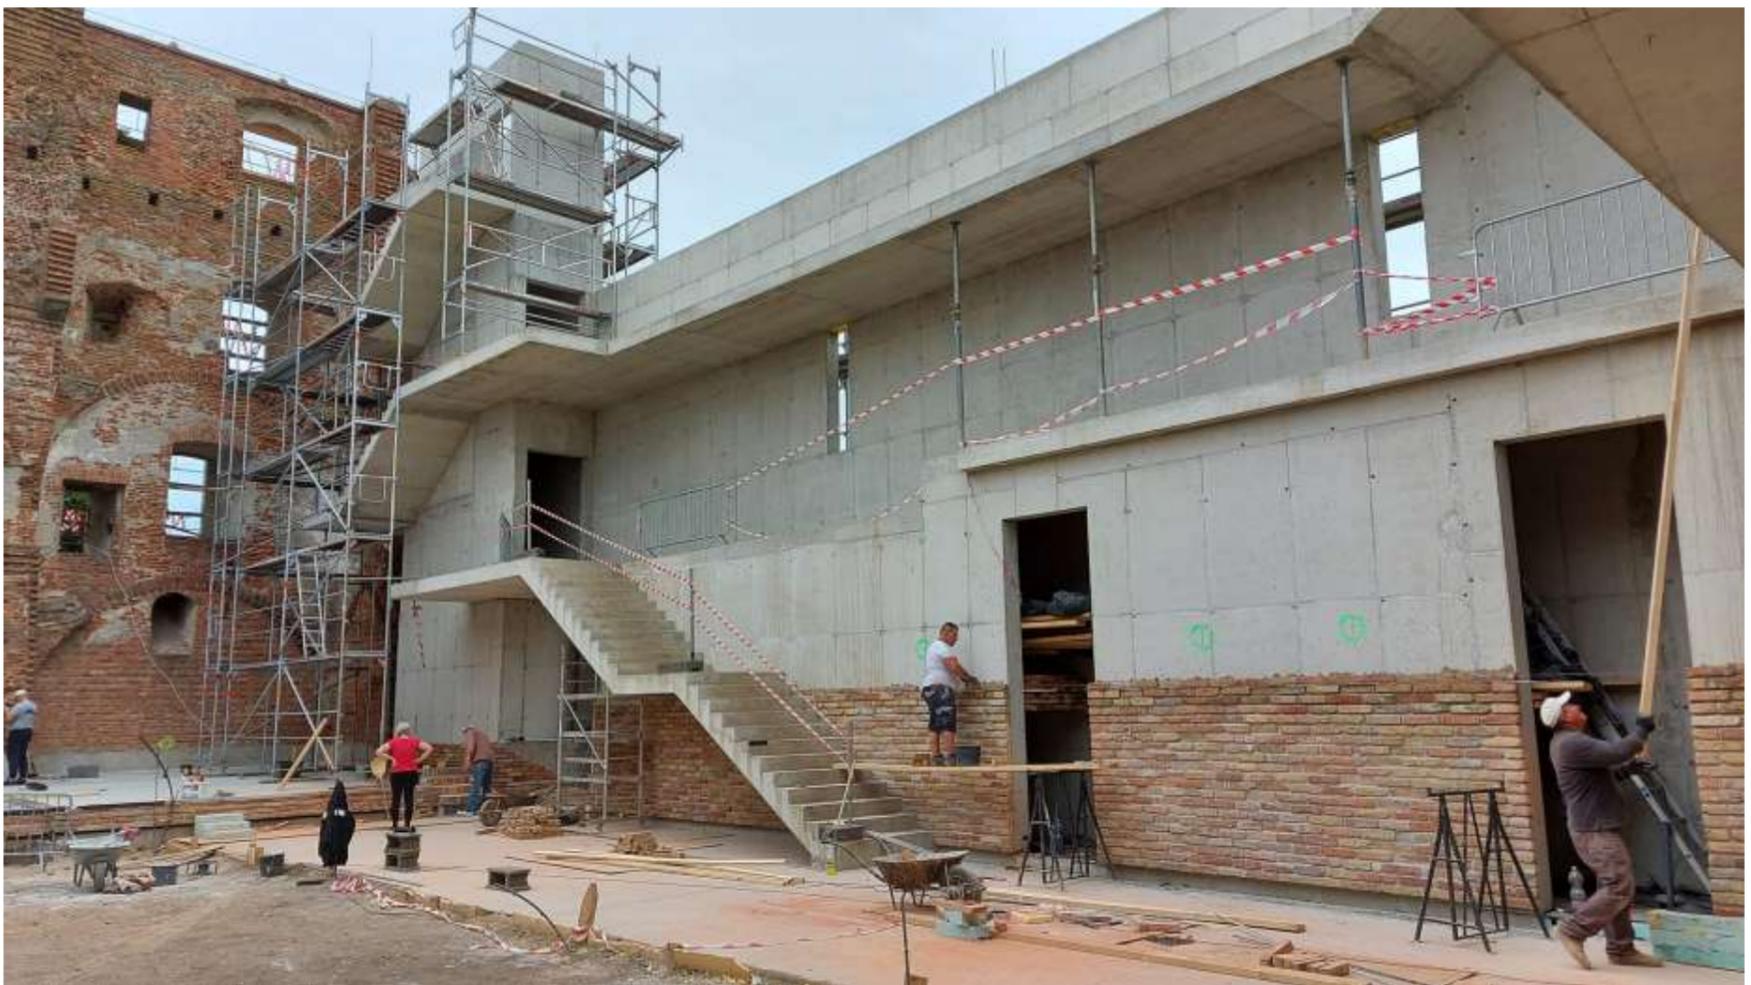
Figure 78. The newly built western wing of the inner castle. László Bodrog's Facebook page, 17. 05, 2022. (Source: <https://www.facebook.com/photo.php?fbid=3237607736470257&set=a.2153755774855464&type=3> Last access: 12.05.2022.)

parts will be conserved, In the case of the castle wings, reconstruction is not a convincing choice, he calls the new structure the evocation of the castle as modern urban planning replaced the buildings bombed during World War II.²⁰⁴
